Assessment of lining ruptures

Assessment/evaluation of cracks and ruptures in the lining layer of disc brake linings

BPW-TI-Belag TSB - 39121101.def

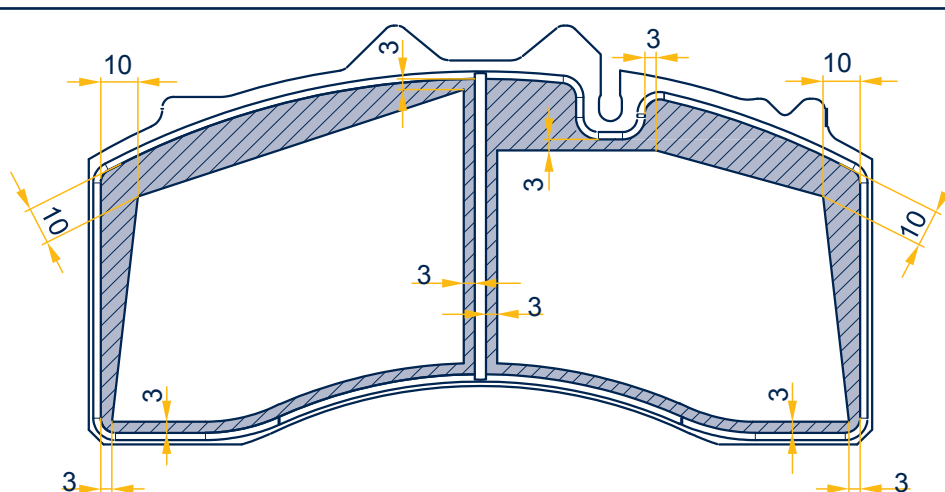
The defined areas shown in Figure 1 may display ruptures to the edges under the following conditions:

- Ruptures are only permissible in the edge areas marked (3 mm from the peripheral edges and the central groove and a maximum of 10 mm to the upper lining corners).
- The ruptures are no larger than shown in Figure 1.
- The total rupture surface is no larger than 10% of the total lining surface.
- The ruptures, as shown in Figure 2, are not in the area of the lining connection (2 mm distance from the lining's backing plate).
- There are no ruptures in other areas.

Figure 1: Permissible areas for edge ruptures are marked, but must be no more than 10% of the lining surface.

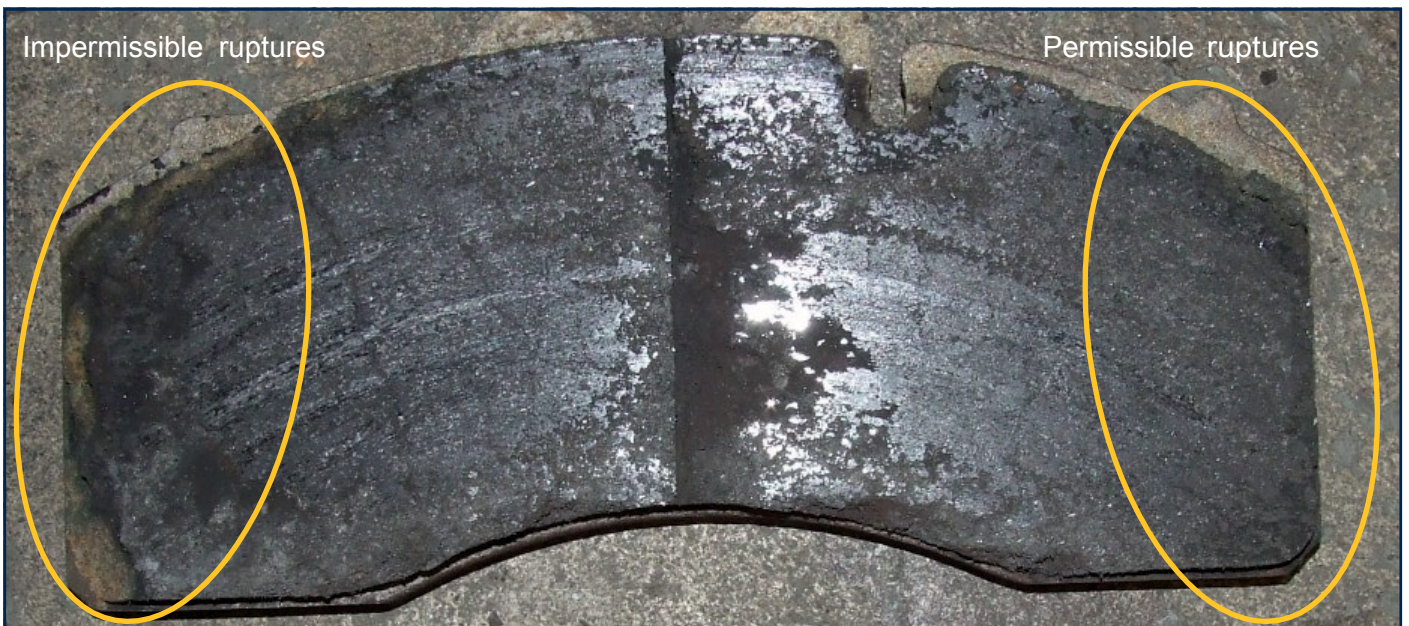
Figure 3 shows a comparison between permissible and impermissible edge ruptures.

Figure 3: Lining with impermissible

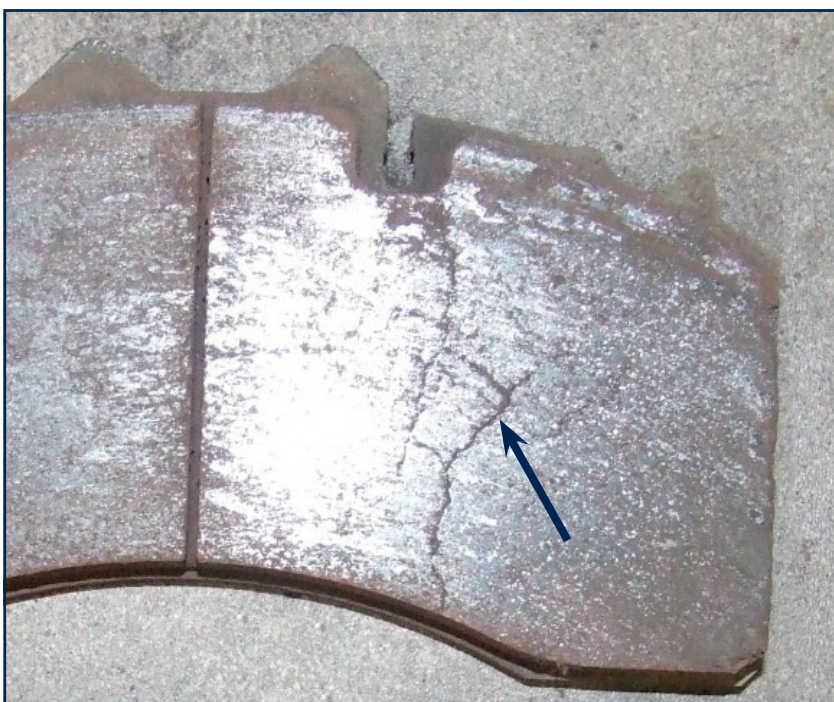
Figure 4: Cracks in the permissible area of the lining surface

The cracks in the lining surface shown in Figure 4 are acceptable under the following conditions:

- The cracks do not go all the way to the lining connection area (2 mm above the lining's backing plate), see Figure 2.
- The cracks do not run horizontal to the backing plate.

The cracks shown do not signify a defective product but instead are a sign of normal wear. Therefore, a replacement of the linings is not yet necessary.
