Wear and damage characteristics on brake cylinders

Component:	Spring-loaded diaphragm brake cylinder
Damage pattern:	Corrosion in the brake cylinder

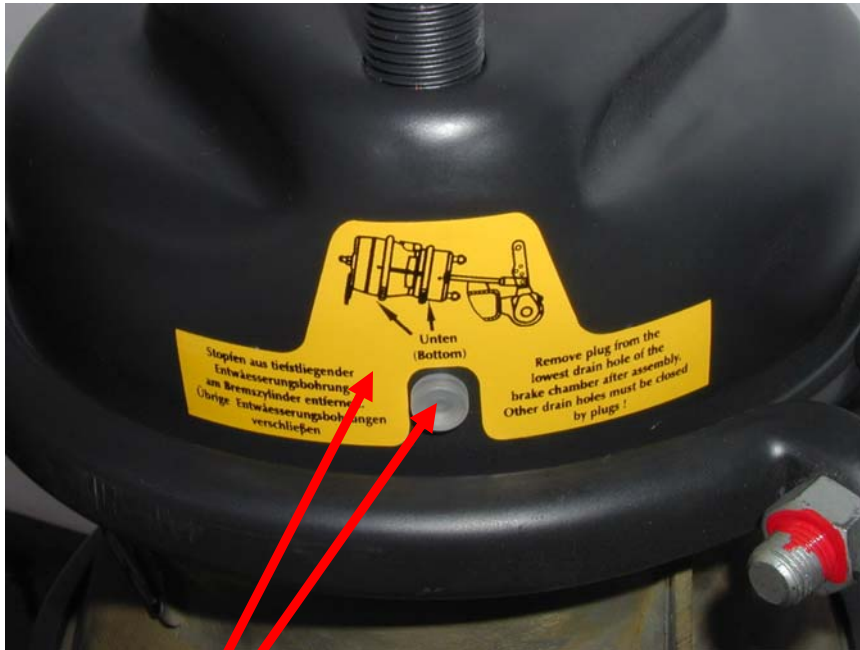
Information sticker for removing the drain plug

All BPW brake cylinders are equipped with an information sticker

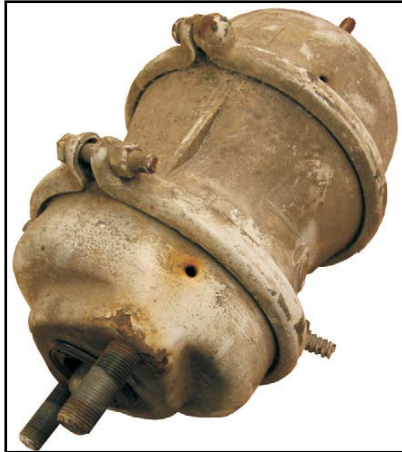
Leakage in the area of the clamping band

This spring-loaded diaphragm brake cylinder is losing air in the area of the clamping band for the service brake section.

Diaphragms are wearing parts and subject to an ageing process. After several years of operation, leaks can result in the clamping area of the diaphragm and the clamping band, leading to a gradual pressure loss.

In spite of the leak, there is no reason to expect sudden total failure of the brake cylinder and therefore of the wheel brake. The air only escapes slowly. The drop in reservoir pressure is made good when the vehicle is driven. If the vehicle is parked up for a long time, however, all the pressure in the service brake system can escape and require re-establishing. The parking brake system will thus remain activated for longer.

If the operating pressure drops whilst the vehicle is being driven, the driver will be made aware of the pressure loss by a warning device. This warning must be respected because a major pressure loss will lead to the trailer brakes being activated automatically. The vehicle must not continue to be driven in this case.

Defective brake cylinders must be renewed. We recommend using genuine parts.

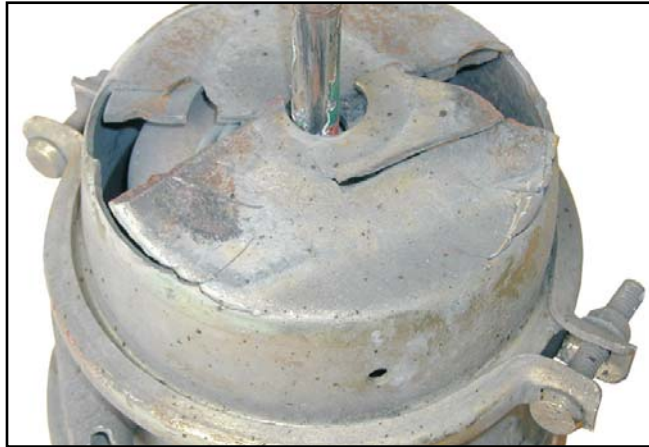
Brake cylinder mounting face torn out due to loose screw connection

The screw fixing studs of the brake cylinder are torn out. Signs of a fatigue fracture can be seen on the fracture surfaces of the brake cylinder.

Brake cylinders are able to handle running gear movements and road bumps without damage. In the case of poor road conditions or during off-road use, impacts can be transmitted to the brake cylinder, which can ultimately lead to fatigue fractures in the housing. This process is accelerated in particular if the screw connections on the brake chamber bracket are loose. Defective shock absorbers can also result in extremely high axle accelerations, which can result in the damage profile indicated.

The movement of the piston rod pushes the brake cylinder away from the brake chamber bracket, instead of controlling the slack adjuster and brake camshaft. This cylinder is no longer able to operate the brake.

Damaged parts must be renewed. It is recommended that genuine components be used.

When driving on poor road surfaces and off-road, the firm seating of the screw connection, as well as the condition of the brake cylinder and the chamber bracket must be regularly checked.

Vehicle owners and vehicle operators are obliged to comply with the stipulations of the vehicle manufacturer for Off-road use and to have the vehicles regularly maintained and repaired by a specialist workshop.
