Assessment of lining ruptures

Assessment/evaluation of cracks and ruptures in the lining layer of disc brake linings

BPW-TI-Belag TSB - 39121101.def

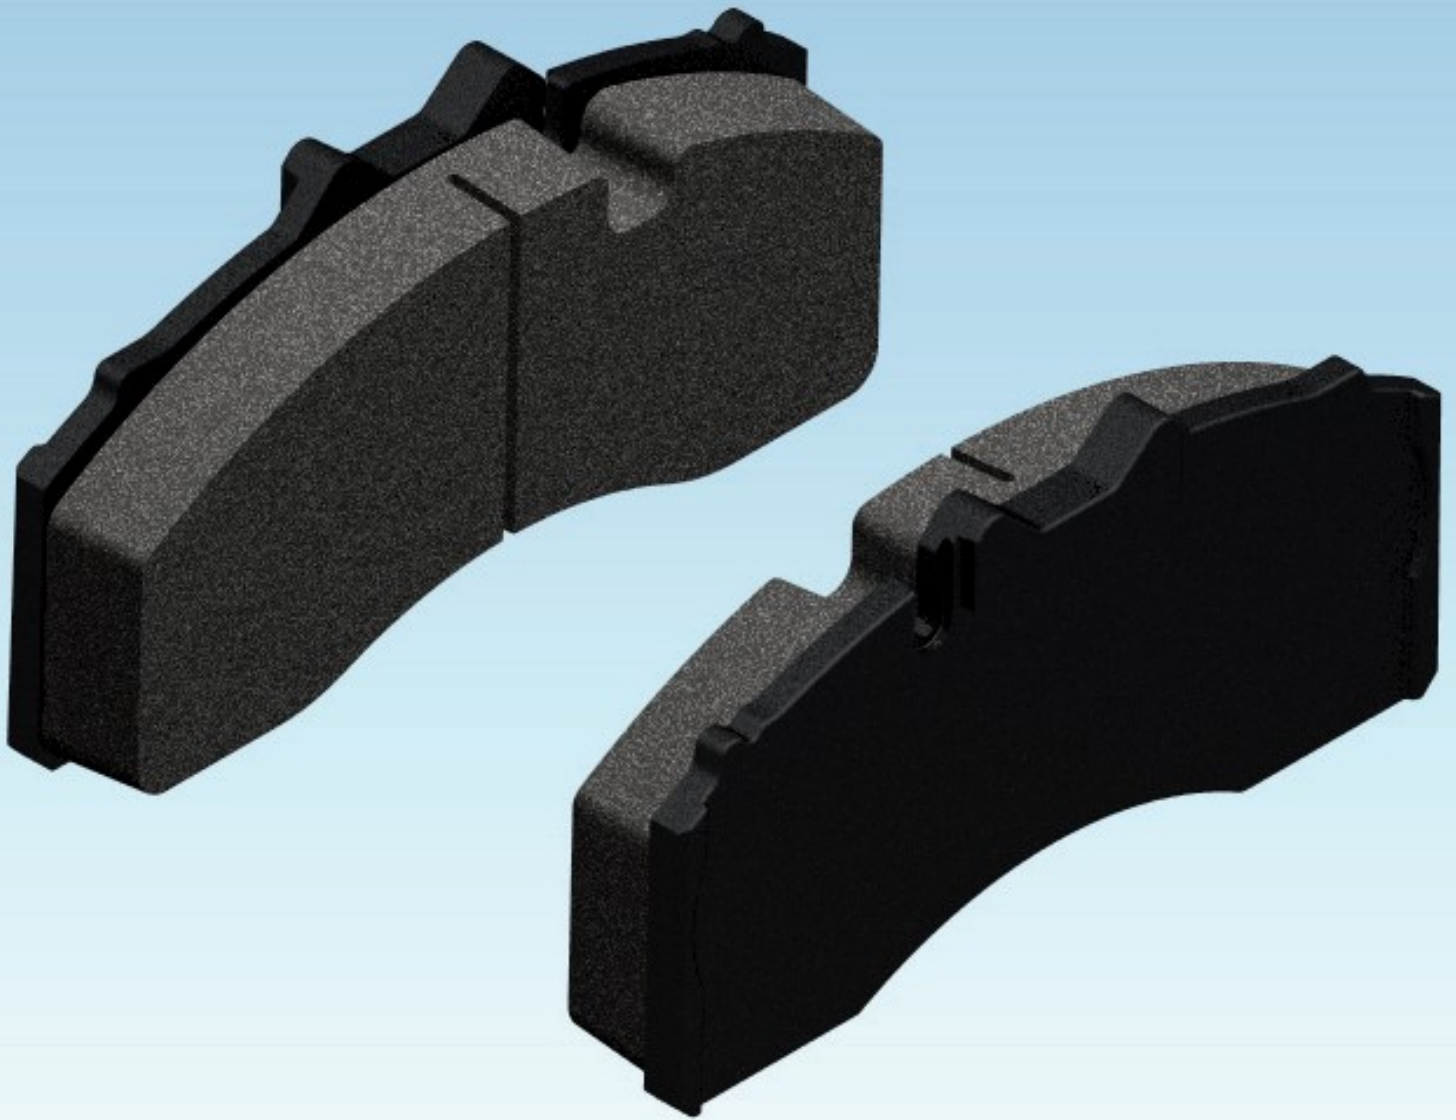
The defined areas shown in Figure 1 may display ruptures to the edges under the following conditions:

- Ruptures are only permissible in the edge areas marked (3 mm from the peripheral edges and the central groove and a maximum of 10 mm to the upper lining corners).
- The ruptures are no larger than shown in Figure 1.
- The total rupture surface is no larger than 10% of the total lining surface.
- The ruptures, as shown in Figure 2, are not in the area of the lining connection (2 mm distance from the lining's backing plate).
- There are no ruptures in other areas.

The ruptures shown above do not signify a defective product but instead are a sign of normal wear. Therefore, a replacement of the linings is not yet necessary.

Figure 1: Permissible areas for edge ruptures are marked, but must be no more than 10% of the lining surface.
